# Factsheet

## Balconies and Balustrades

This fact sheet aims to assist Owners Corporations in understanding the individual components that make up the balcony and balustrade structure, when balconies and balustrades require an upgrade and key issues that should be considered prior to and during a balcony remediation project.

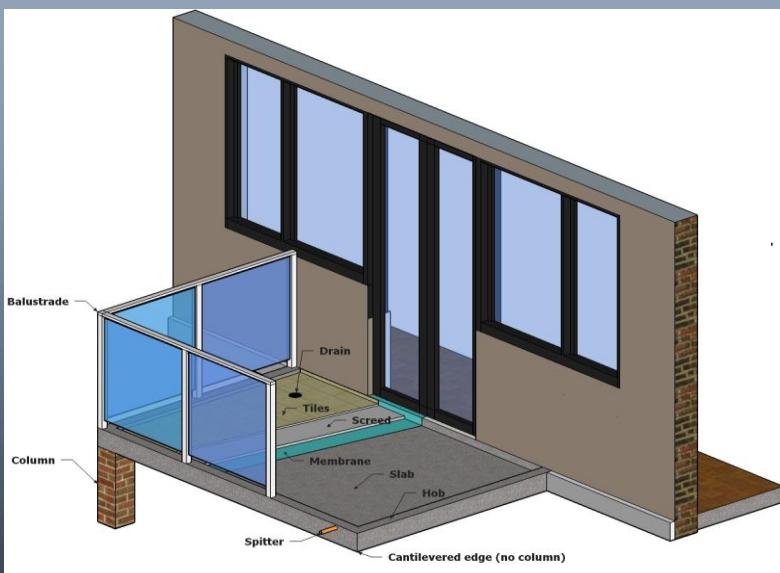
Figure 1 - Balcony & balustrade components

- **Concrete slab** – The concrete slab forms the main structural component of the balcony. Occasionally balconies in residential buildings will be constructed using timber or other light framed material however more often than not, the floor structure is constructed out of reinforced concrete. Slabs can either be cantilevered or supported by columns or walls, with each support mechanism having different implications with regards to remedial works.

- **Columns/Walls** – Balconies can be supported on their outer edge by columns and or walls in lieu of the balconies being cantilevered. These types of balconies are referred to as being simply supported. Simply supported balconies are more forgiving on the concrete slab and it could be argued that simply supported balconies are less prone to long term structural issues and are also easier to remediate if required.

- **Waterproof Membrane** – The waterproof membrane is installed directly onto the slab and is used to prevent moisture ingress to the interior of the unit and to protect the concrete slab from absorbing excessive moisture which can lead to concrete cancer.

- **Screed and tiles** – Tiles are installed on a bed of screed with incorporated falls to allow the balcony to drain adequately to the appropriate outlet.
- **Hob** – A hob relates to a solid upturn around the perimeter of the balcony. Hobs assist with controlling stormwater runoff by preventing water from simply falling over the edge.
- **Drainage** – Balconies have one of the following drainage mechanisms installed:
  - Drain connected to a downpipe.
  - Drain connected to a downpipe with spitters installed in a hob as secondary drainage.
  - Spitters only installed in a hob as primary drainage.
  - No downpipe or spitters (no hob).

- **Balustrades** – Balustrades prevent occupants from falling from balconies and as such must comply with several stringent requirements as outlined in the Building Code of Australia. The notable requirements include:
  - Height must be greater than 1000mm.
  - Must be able to withstand loads in accordance with Australian Standards (AS1170).
  - Must not allow a 125mm diameter sphere to pass through any portion. Think about the size of a child or baby's head.
  - Must not have horizontal elements that facilitate climbing between 150mm and 760mm if protecting a fall of 4m or greater.

Undertaking works to one component ultimately affects another. The key components of a balustrade structure are outlined below and identified in **Error! Reference source not found..**
