Factsheet

Balconies and Balustrades

This fact sheet aims to assist Owners Corporations in understanding the individual components that make up the balcony and balustrade structure, when balconies and balustrades require an upgrade and key issues that should be considered prior to and during a balcony remediation project.

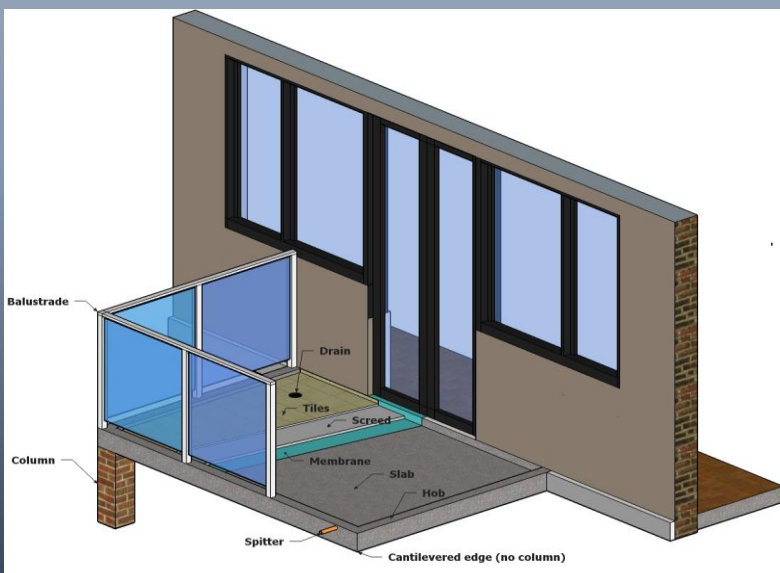
Figure 1 - Balcony & balustrade components

- **Concrete slab** – The concrete slab forms the main structural component of the balcony. Occasionally balconies in residential buildings will be constructed using timber or other light framed material however more often than not, the floor structure is constructed out of reinforced concrete. Slabs can either be cantilevered or supported by columns or walls, with each support mechanism having different implications with regards to remedial works.

- **Columns/Walls** – Balconies can be supported on their outer edge by columns and or walls in lieu of the balconies being cantilevered. These types of balconies are referred to as being simply supported. Simply supported balconies are more forgiving on the concrete slab and it could be argued that simply supported balconies are less prone to long term structural issues and are also easier to remediate if required.

- **Waterproof Membrane** – The waterproof membrane is installed directly onto the slab and is used to prevent moisture ingress to the interior of the unit and to protect the concrete slab from absorbing excessive moisture which can lead to concrete cancer.

- **Screed and tiles** – Tiles are installed on a bed of screed with incorporated falls to allow the balcony to drain adequately to the appropriate outlet.
- **Hob** – A hob relates to a solid upturn around the perimeter of the balcony. Hobs assist with controlling stormwater runoff by preventing water from simply falling over the edge.
- **Drainage** – Balconies have one of the following drainage mechanisms installed:

- **Balustrades** – Balustrades prevent occupants from falling from balconies and as such must comply with several stringent requirements as outlined in the Building Code of Australia. The notable requirements include:

Undertaking works to one component ultimately affects another. The key components of a balustrade structure are outlined below and identified in **Error! Reference source not found..**
